Sediment Transport and Its Impacts on Lake Kivu, Gihira Water Treatment Plant and Various Hydropower Plants along Sebeya River in Rwanda

How to cite this paper: Majoro, F., Wali, U.G., Munyaneza, O., Naramabuye, F.-X., Bugenimana, E.D. and Mukamwambali, C. (2020) Sediment Transport and Its Impacts on Lake Kivu, Gihira Water Treatment Plant and Various Hydropower Plants along Sebeya River in Rwanda. *Journal of Water Resource and Protection*, 12, 934-950.
<https://doi.org/10.4236/jwarp.2020.1211055>

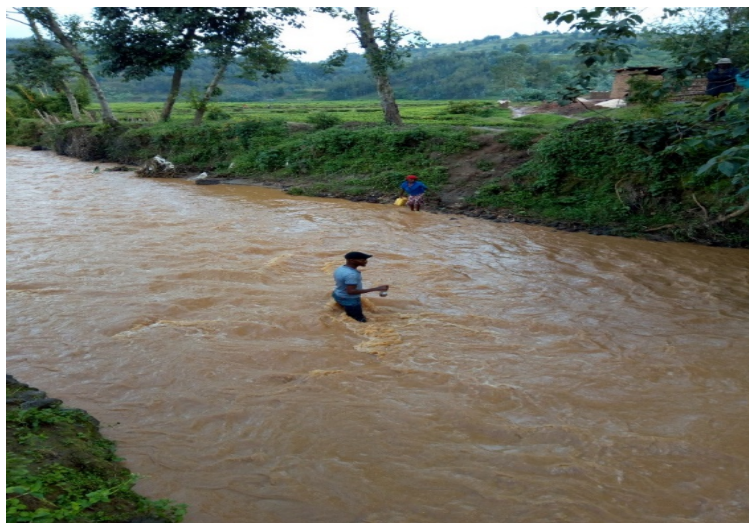
Figure 3. Sebeya river water sampling.

Samples were hand-collected in the catchment at five selected sampling points.

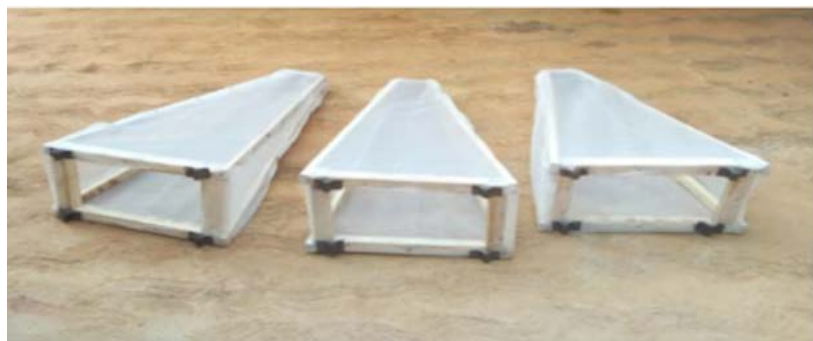
Figure 4. Bed load sampler.

The sampler used for this study (**Figure 4**) was designed referring to the description given by [11]. The characteristics of the designed sampler are as follows: opening front size of 0.3 m * 0.2 m (large enough to allow sediments to enter), total length of 0.9 m and the mesh size of 3.9 mm (for capturing different sizes of sediments greater than 3.9 mm). For bed load sampling, 3 samplers were immersed at the bottom of the river at 3 equidistant points along the river cross-section (at 2 m, at 4 m and at 6 m from the river bank). Before starting the sampling process, the mass of each empty sampler was recorded and samplers placed in contact with the river bed against the flow, allowing the sediment transported as bed load to accumulate or be trapped inside the sampler for 1 hr (Long duration for the collection of infrequently moving large particle sizes near the threshold of motion). After one hour, the samplers were raised up to the surface and the weight of the content of each sampler was recorded. The bed load from the 3 samplers were well mixed and 1 kg taken from this mixture for further analysis in the laboratory.
