# Investigation into Road Construction Safety Management Techniques

That is why an investigation to safety management techniques was conducted in order to have a better understanding to the prevailing situation on some selected works for Nyarugenge sector (Agatare) infrastructure upgrading, road construction of Ruliba-Karama-Nyamirambo and Road construction of Sonatube-Gahanga-Akagera in the City of Kigali.

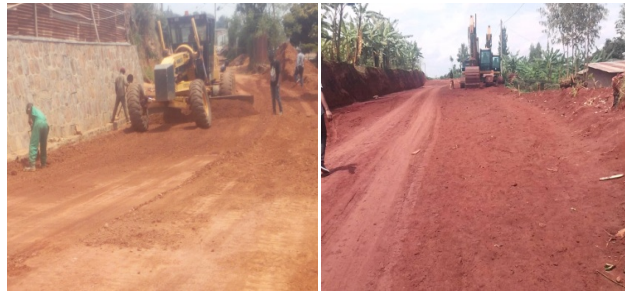
**Figure 1.** Lack of safety measures for site workers with construction equipment.

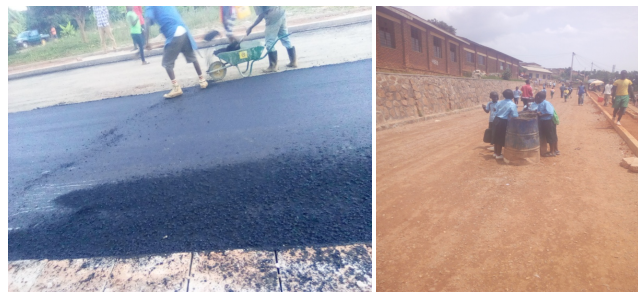
**Figure 2.** Lack of safety measures to road Workers for asphalt and land surveying activities and road users like children.

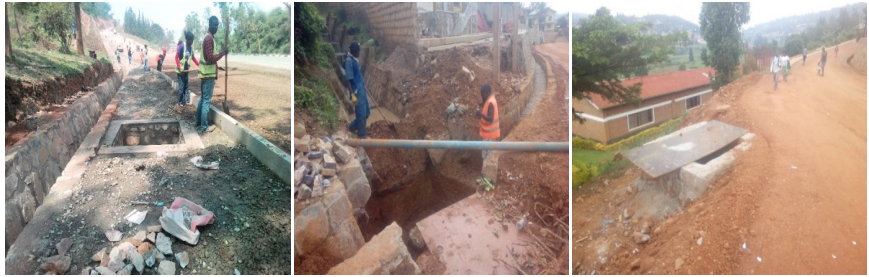
**Figure 10.** Lack of protective information for Manholes at Karama, Akagera and Agatare roads respectively.

- The establishment of a workplace health and safety committee would be suggested on road construction site;
- A construction site should be having a copy of safety rules and guidelines at work and the Safety guidelines must be provided separately depending on type of work not in general;
- The paper also recommended to follow the following guidelines as per IS 13430:1992, reviewed in 2007 which are not included in Rwanda's guidelines but are exclusively important to follow and include caution signs and marked with red lights at suitable intervals, notice boards and danger signals should be provided; danger lights during darkness hours, Barriers or coverings should be provided to excavations, distance where to park unused equipments;

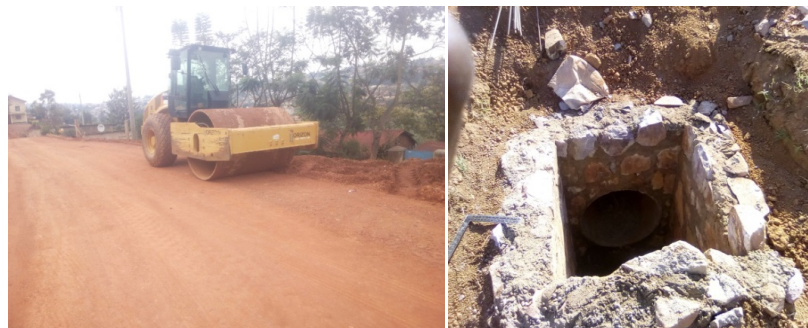
**Figure 12.** Lack of Adequate Signs to warn parked Machine at Karama Road and a manhole under construction at Akagera Road.

**Figure 12** illustrates the field situation of the lack of adequate signs to warn about parked machines and equipment on road construction site and exposes the danger about non-covered and protected manholes.
