# Smart Sewers 1: Sewer Configuration at Rural Houses

**How to cite this paper:** McDermott, R., Strong, W.A., Griffiths, P., Littlewood, K. and Doherty, M.G. (2020) Smart Sewers 1: Sewer Configuration at Rural Houses. *Journal of Water Resource and Protection*, **12**, 825-834.  
<https://doi.org/10.4236/jwarp.2020.129048>

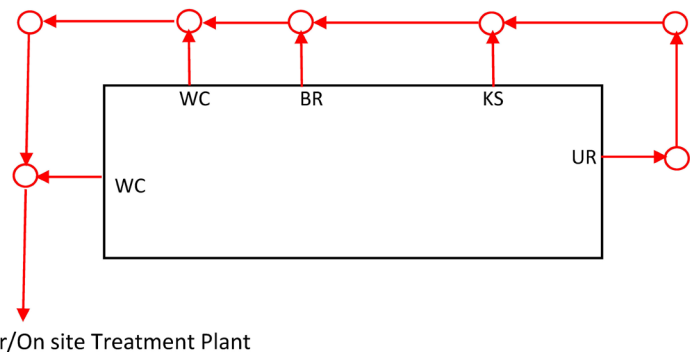
**Figure 2.** House plan schematic showing revised flow direction of external foul pipework.

useful water from the bathroom, kitchen sink and utility room were lost. **Figure 2** shows how a simple change in direction of the foul pipework made use of these outlets in terms of solid transfer from WCs. This option shown in **Figure 2** also assists with the option of greywater recycling, if feasible. The layout of locations that have WC such as bathrooms and ensuites within themselves is an important consideration to ensure that the greywater discharge is upstream of the WC discharge.

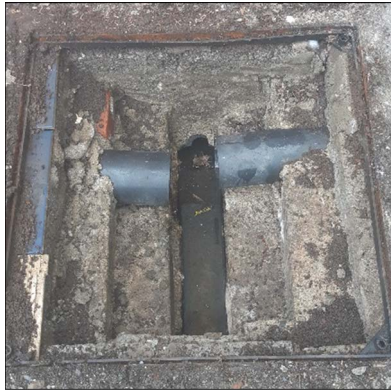
to be used. Circa 21% of the AJs/chambers and their covers were in poor condition. For example, **Figures 3-5** are from the first chamber at the first house surveyed. **Figure 3** shows the chamber with the cover removed. This chamber had standing water with the next downstream chamber having no standing water. A check on the invert levels showed a back fall of 0.026 m between the invert level of both chambers. The cover frame is out of alignment as is the cover which can be seen in **Figure 4** and **Figure 5**. It should be noted that there were chambers in considerably poorer condition. This led to actions that had to be taken including replacing nine covers where the existing covers could not be seated back into the

**Figure 3.** First chamber at the first house surveyed (H1 F1).

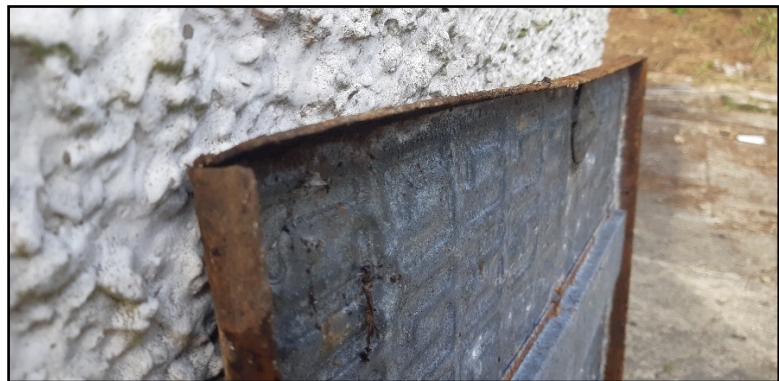
**Figure 4.** H1 F1 galvanized steel cover with damaged flange.

frame properly or where covers cracked upon removal. Replacing covers, particularly where a replica replacement cover is not available, can have considerable costs. This also applies when the cover is located under an asphalt or concrete surface. These issues influenced the speed of the survey work but did not challenge the integrity of the hydraulic findings.

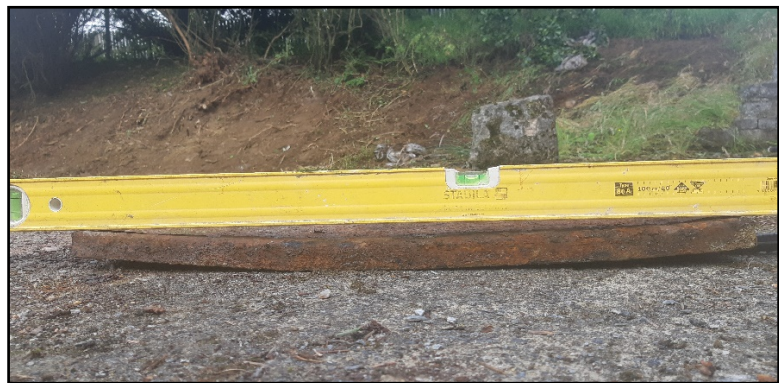
**Figure 5.** H1 F1 galvanized steel cover rusted and deflected.
